Docket No. 217 – Development and Management Plan Inspection

Northeast Utilities Service Company Certificate of Environmental Compatibility and Public Need for the construction of a 345-kV electric transmission line and reconstruction of an existing 115-kV electric transmission line between Connecticut Light and Power Company's Plumtree Substation in Bethel, through the towns of Redding, Weston, and Wilton, and to the Norwalk Substation in Norwalk, Connecticut.

Date: July 19, 2006

Location: Overhead Line (Composite 345kV and 115kV Gallows Hill to Archers Lane,
345kV H-Frame Hoyts Hill to Gallows Hill, and Norwalk Section)

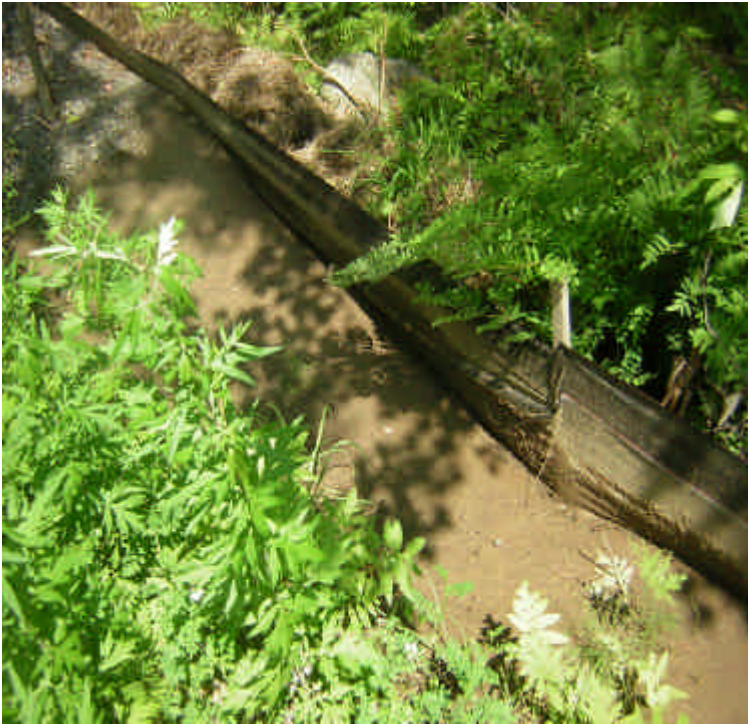
| Areas of Inspection | Observation | Recommended Action | Corrective Action |
|---|--|--|--|
| | - One spot along the access road past Archers Lane has sediment from the road overtopping the silt fence adjacent to the wetland. A second spot is also piling up. 6/7-7/19/06. | - Repairs should be made either by transition station or overhead crews. Stone/sediment needs to be removed. 6/1-7/19/06. | -Needs attention |

(Composite Section): Photo on the left shows further sediment piling up at the silt fence along the access road on the Archers Lane ROW. This is immediately adjacent to a wetland. Photo on the right shows the 2nd wetland crossing where some sediment had accumulated. 7/19/06

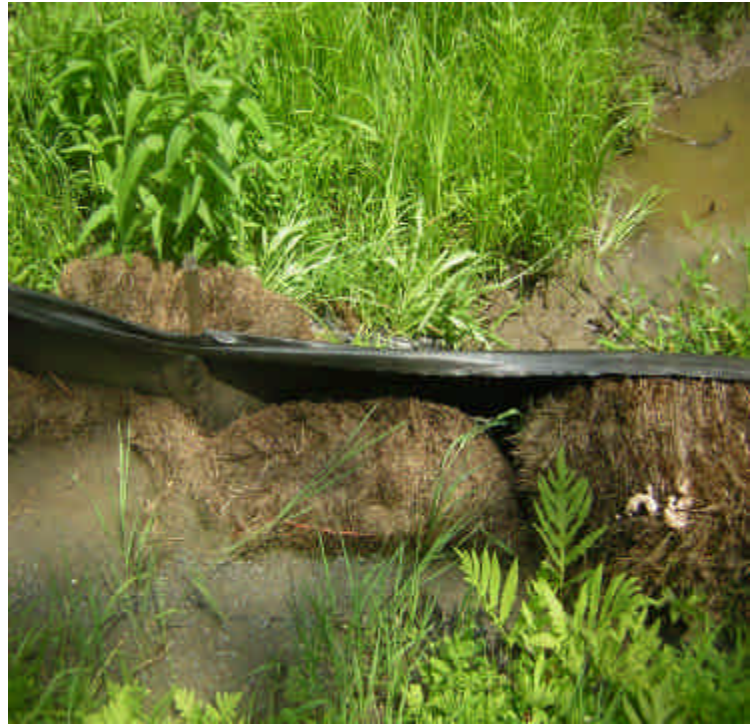
| Areas of Inspection | Observation | Recommended Action | Corrective Action |
|---|--|--|--|
| | - The 2nd crossing also had some sediment | - Sediment should also be removed and repairs | - Needs attention - also see transition station |

| Areas of Inspection | Observation | Recommended Action | Corrective Action |
|---|--|--|---|
| 345kV H-Frame | accumulation in the wetland along the access road. 7/19/06 | made to the controls here. The contractor hired for the 1 st wetland near Archers Lane should also work in this area. 7/19/06 | report. |

| Areas of Inspection | Observation | Recommended Action | Corrective Action |
|--|---|---|---|
| Composite | <ul style="list-style-type: none"> - Some sediment had accumulated in the 2nd crossing and turbid run-off had been noted previously in the 3rd | <ul style="list-style-type: none"> - Repair crossing controls and identify where the run-off was entering 6/28-7/19/06. | <ul style="list-style-type: none"> -Needs attention |

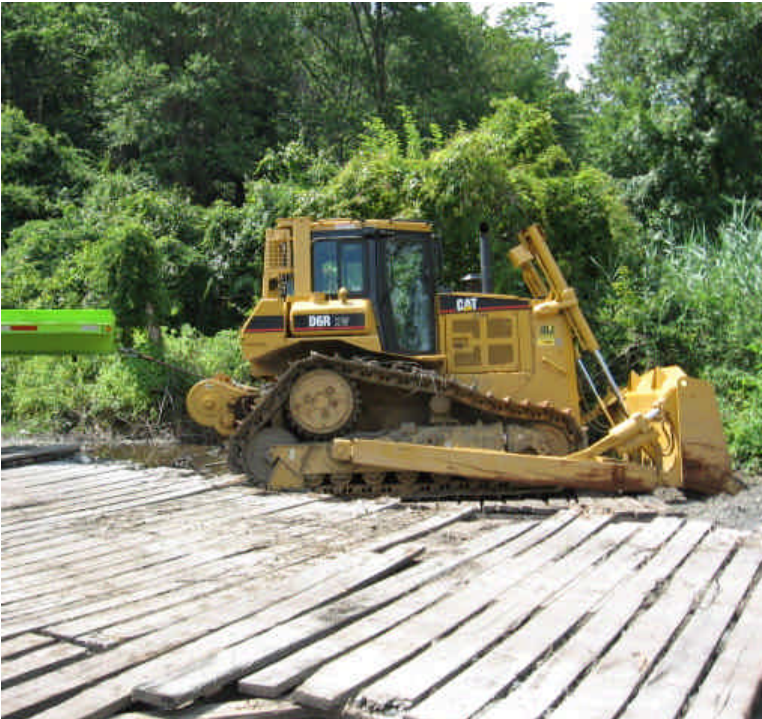
| Areas of Inspection | Observation | Recommended Action | Corrective Action |
|---|--|--|---|
| | - Mats are in place within the wetland off Rt 58 at Hoyts Hill to support wire pulling equipment. However, one of the machines has slid partially off the mat. 7/19/06 | - Make immediate plans to remove this equipment from the wetland surface and place on the stable mat. 7/19/06 | - Needs attention ASAP |

| Areas of Inspection | Observation | Recommended Action | Corrective Action |
|---|---|---|---|
| Spills and Material Storage | -None of the parked or active equipment was leaking at the time of inspection. 3/15-7/19/06. - However, a piece of machinery is partially off the mats on Rt 58. Stabilize immediately. 7/19/06 - In general, equipment should be parked over 100 ft from resource areas or as far as feasible. 7/19/06 | - Continue to keep all vehicles maintained well (i.e. no apparent fluid leaks) if they will be used or stored on site - Keep adequately size fuel kits for worst-case scenarios. - Report spills immediately, even if they are being controlled. - Avoid refueling in the areas near the wetlands. Use proper storage for all materials. | -N/A - Needs attention ASAP |

(345kV H-Frame): Photo on the left shows where a piece of equipment for wire pulling near Hoyts Hill has partially slipped off a mat at the wetland edge. It is attached to the other equipment but must be stabilized immediately. Photo on the right shows a view of the driveway being constructed by the residential contractor (non project related). 7/19/06.

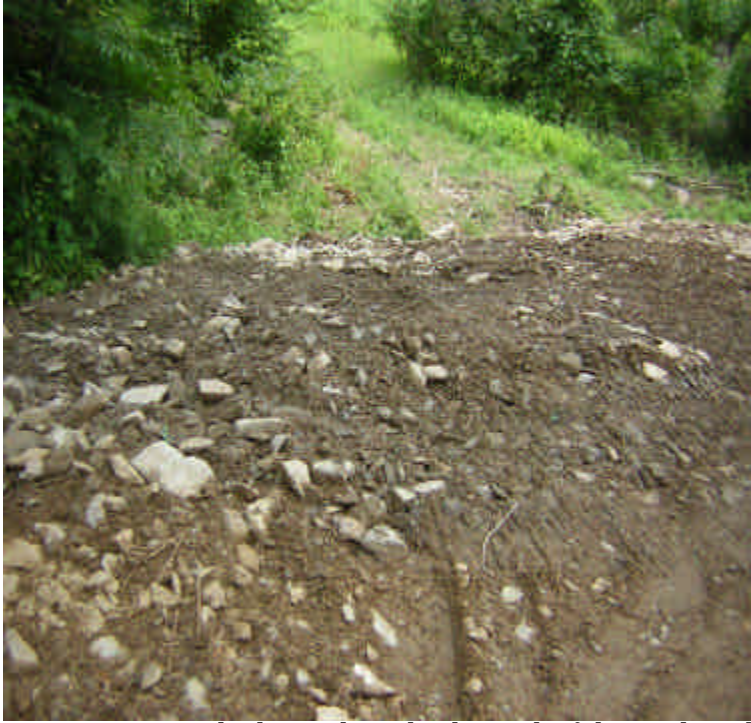
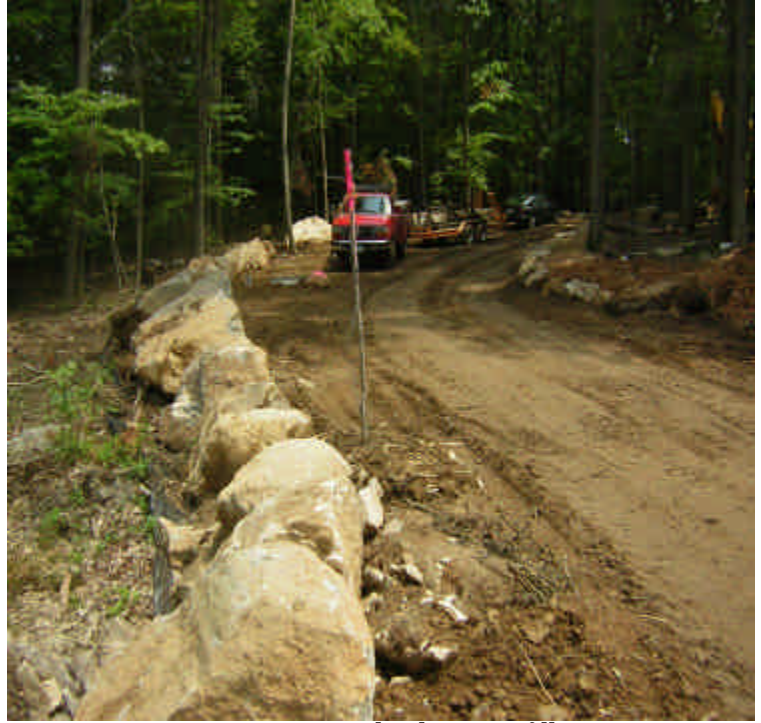
Both photos show the the work of the residential contractor near structure #24. The driveway fill appears to encroach on the wetland. 7/19/06

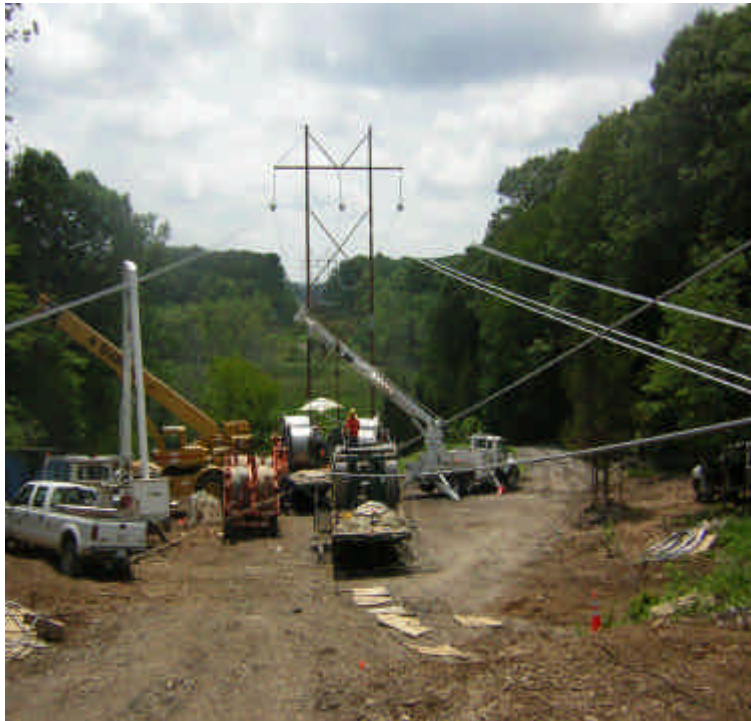
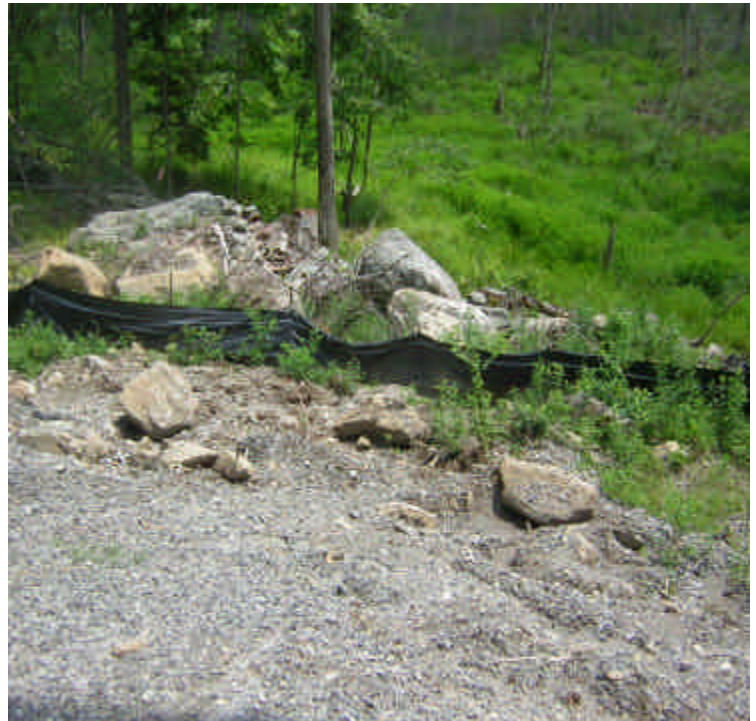
Photo on the left shows the wire pulling continuing near John Todd Way. Photo on the right shows the silt fence near structure #25 in fairly good shape. 7/19/06.

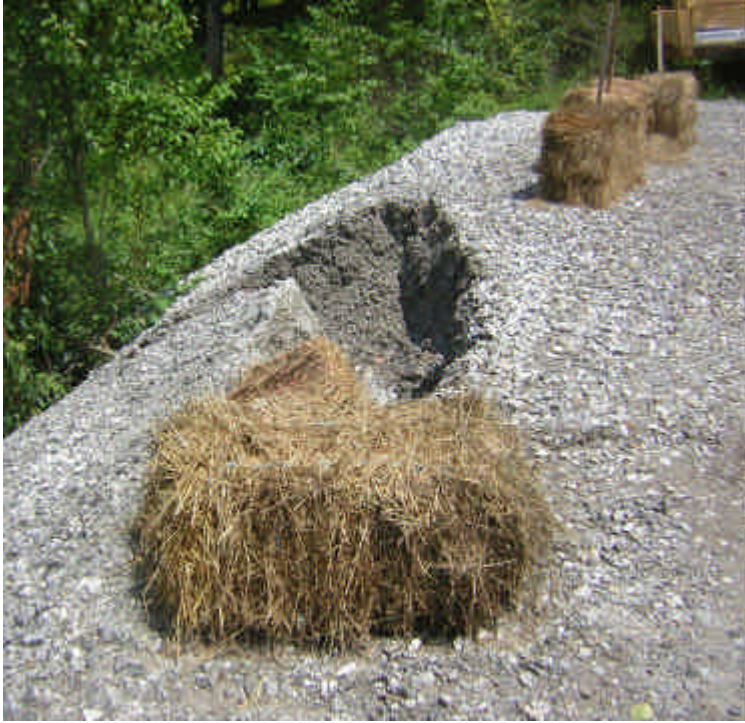
| Areas of Inspection | Observation | Recommended Action | Corrective Action |
|---|--|--|---|
| | - The access road erosion near structure #31 was regraded but erosion returned even with the haybales in place. 7/19/06. | -Continue to monitor and keep stone out of any resource areas. 7/19/06 | -The constructed swale here was filled. Look into more permanent solutions. |

Photo on the left shows where erosion had re-formed near structure #31. (Arrowhead Rd) Photo on the left shows foundation drilling occurring near the railroad track here. 7/19/06.

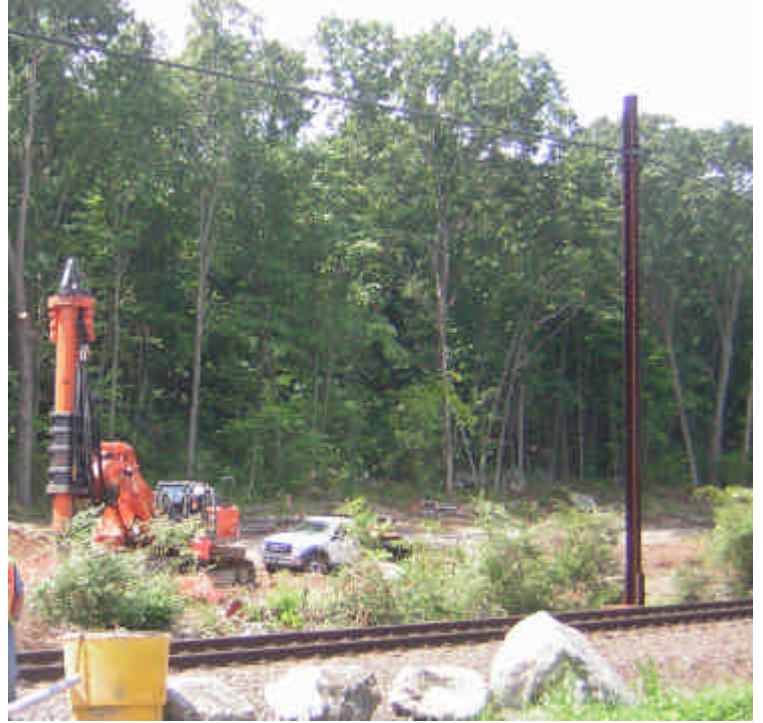
| Areas of Inspection | Observation | Recommended Action | Corrective Action |
|---|---|--|--|
| | - Foundation drilling continues in the section south of Arrowhead Rd. moving towards the pond. Drilling was noted near the railroad track and the foundation hole was in place at the wetland location. 7/19/06 | - See erosion controls section for information. 7/19/06. | - N/A |

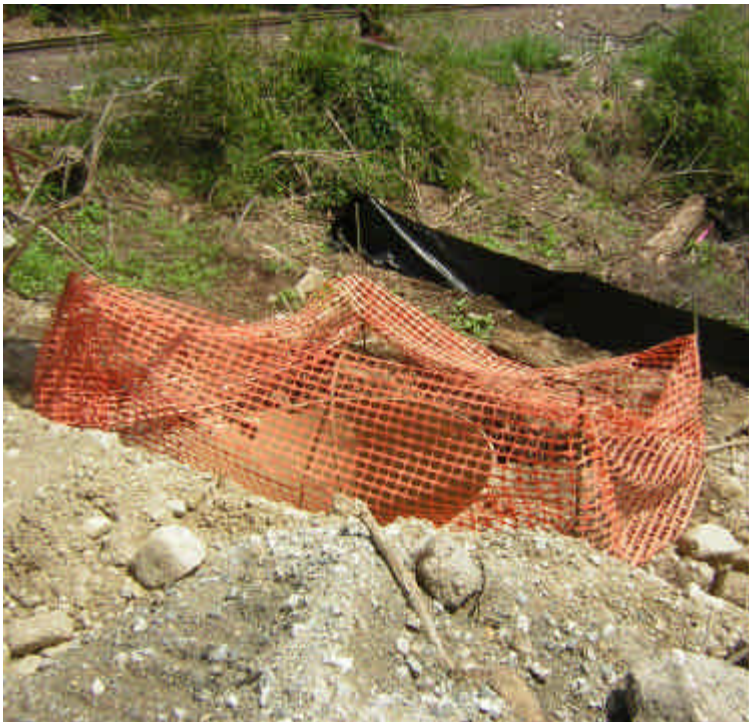
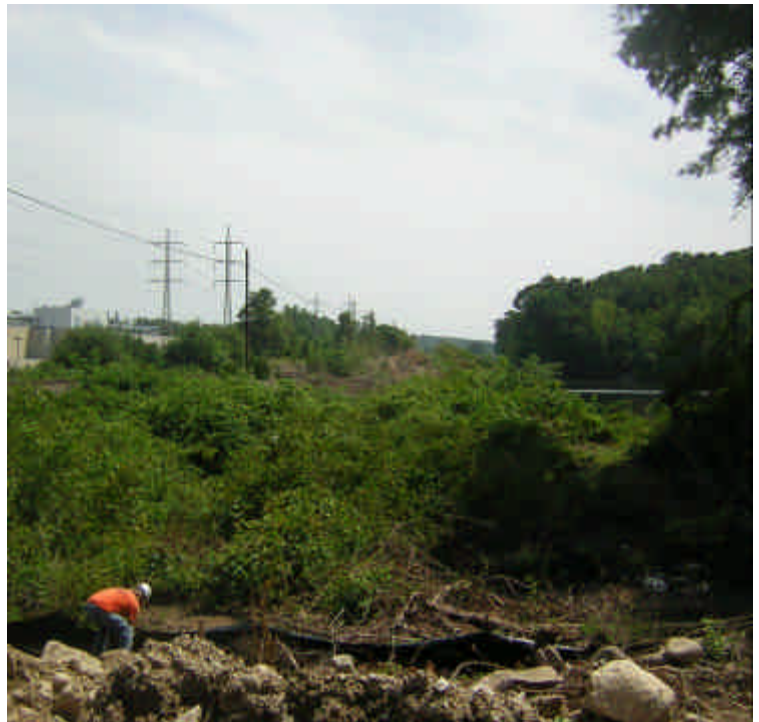
| Areas of Inspection | Observation | Recommended Action | Corrective Action |
|--|---|---|---|
| Erosion controls continued | <ul style="list-style-type: none"> -The foundation was drilled off Wilton Terrace at the edge of the wetland. Silt fence is in place and the location was pulled to the edge of the access road. 7/19/06 | <ul style="list-style-type: none"> - Continue to monitor and maintain silt fence when necessary. 7/19/06 | <ul style="list-style-type: none"> -Silt fence was installed prior to the work |

Photo on the left shows the foundation hole drilled in the area at the edge of the wetland near the Kent Rd pond. The location was pulled as close to the access road as possible. Photo on the right shows maintenance of the silt fence installed in this area. No sedimentation was noted in the wetland here. 7/19/06

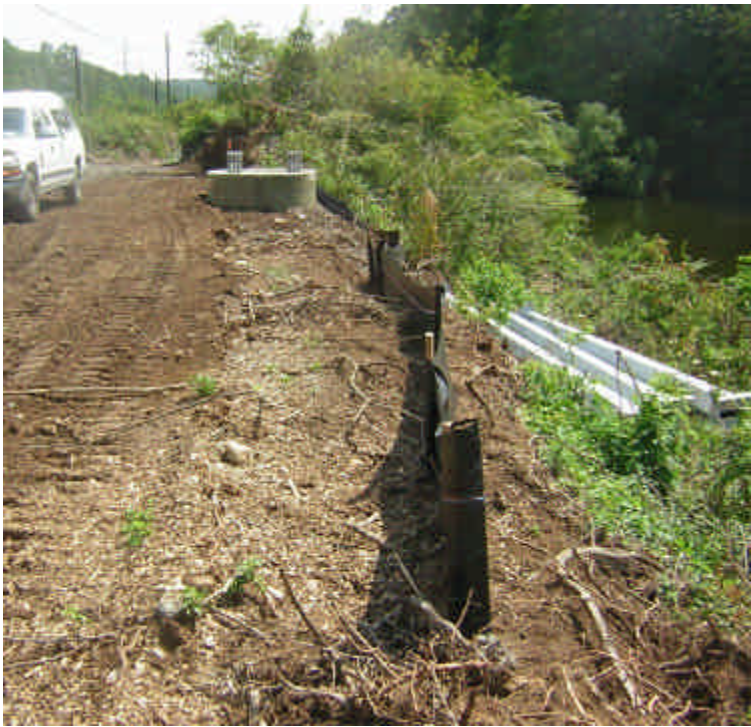
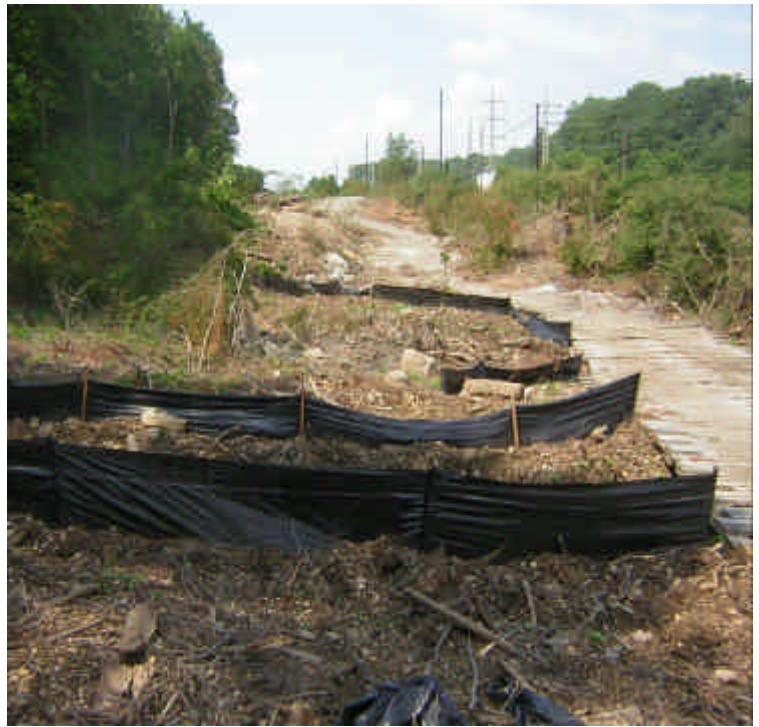
| Areas of Inspection | Observation | Recommended Action | Corrective Action |
|--|---|---|---|
| | <ul style="list-style-type: none"> - Silt fence was extended along both banks of the stream and near the foundation at the pond in the Kent Rd north section. 7/19/06. | <ul style="list-style-type: none"> -Continue to monitor and maintain as needed. 7/19/06 | <ul style="list-style-type: none"> - Silt fence is in place |

(Kent Rd) Photo on the left shows the silt fence installed at the foundation near the edge of the pond, north of Kent Rd. Photo on the right shows the silt fence extended along both banks of the stream as recommended. 7/19/06

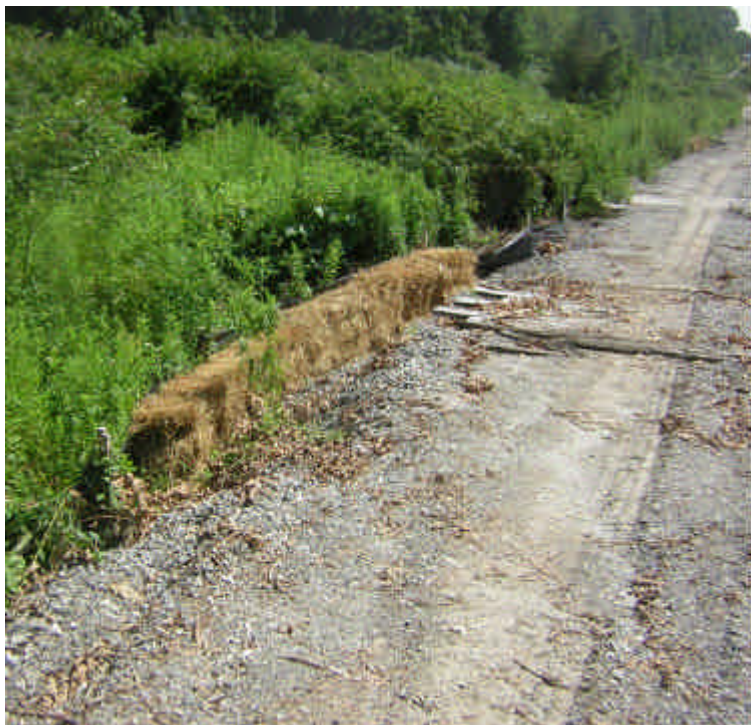
| Areas of Inspection | Observation | Recommended Action | Corrective Action |
|--|---|---|---|
| Kent Rd. (South) | <ul style="list-style-type: none"> - Mats are installed along much of the ROW south of Kent Rd. The silt fence was reinforced with haybles in the spots that had washed out. 7/19/06. | <ul style="list-style-type: none"> -Continue to repair and reinforce. These areas will be difficult to control during heavy rain due to the drainage patterns. 7/12-7/19/06 | <ul style="list-style-type: none"> - Haybales were installed |

Photo on the left shows haybales placed to reinforce the silt fence adjacent to the access road south of Kent Rd. This area has a tendency to wash out. Photo on the right shows a spot of the silt fence just north of the Norwalk Substation where sediment is about to overtop. 7/19/06

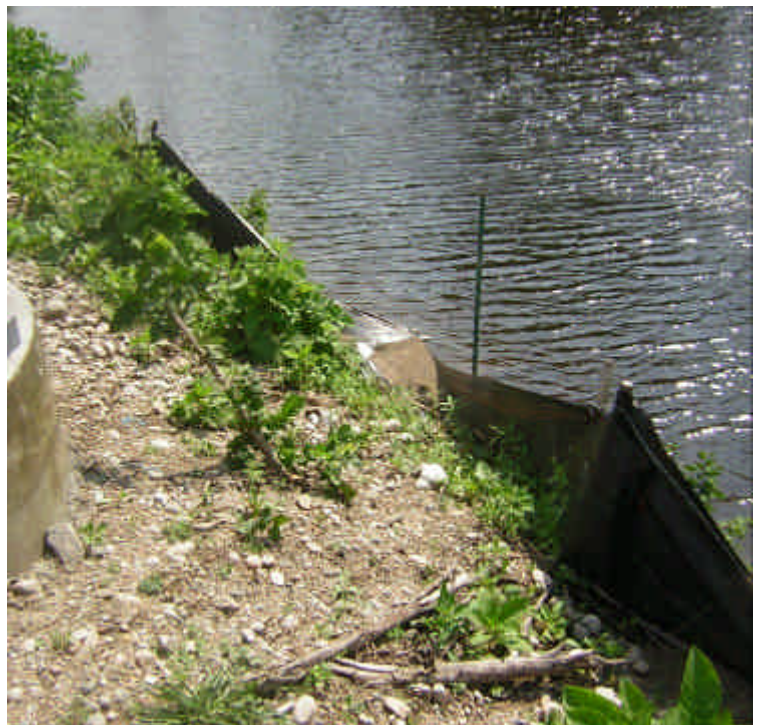
| Areas of Inspection | Observation | Recommended Action | Corrective Action |
|--|---|---|---|
| Kent Rd. (North – new ROW section) | <ul style="list-style-type: none"> - The silt fence near the foundation at the Norwalk substation was almost washed over. 7/19/06. Bare, exposed soil remains adjacent to the foundation. 6/7-7/19/06 | <ul style="list-style-type: none"> - Restore the adjacent area with vegetation to reduce potential run-off, even if it is temporarily. 6/7-7/19/06 Restore and reinforce the controls here. 7/19/06 | <ul style="list-style-type: none"> - Needs attention |
